# INSPECTION PIT SAFETY IMPROVED WITH BELZONA

ID: 466

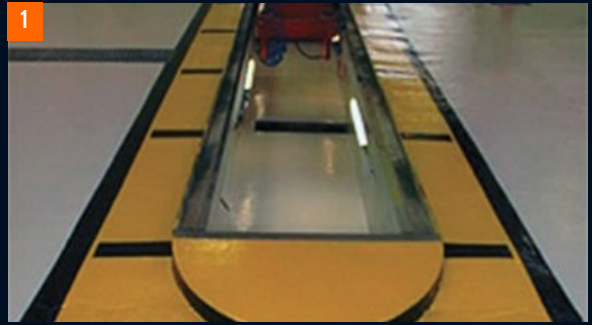
1. Overview of the inspection pit, following application.
2. Belzona systems improve safety on steps too.

After scabbling the concrete and planing rough areas a two-coat system of Belzona® 5231 was applied to the workshop floor and inspection pit. An additional strip of Belzona® 4411 grip system was applied to step nosings to provide additional grip and safety.
