# BELZONA SAVES REFINERY FROM DAILY LOSSES OF £1.5M

Flare line at refinery.

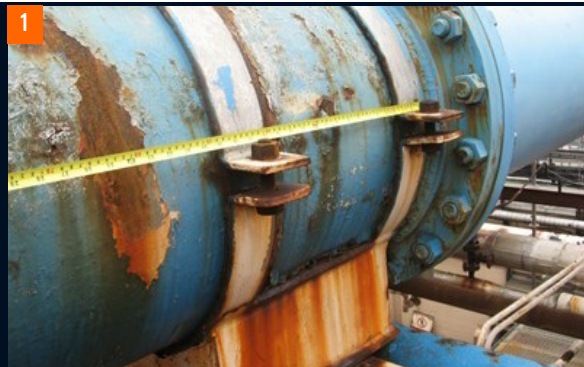
Severe external corrosion had reduced wall thickness. The client required a fast solution to this problem with minimal service disruption. After all, every day of shutdown was costing them £1.5 million.

1. Corroded and pitted pipework
2. Temporary wrap over holed area
3. Application of chemical resistant wrap
4. Final wrap and flange encapsulation
