# BELZONA COATS A SHOWER FLOOR AND PREVENTS MAJOR WATER ISSUES

ID: 4663

Communal shower floors at an Army Base

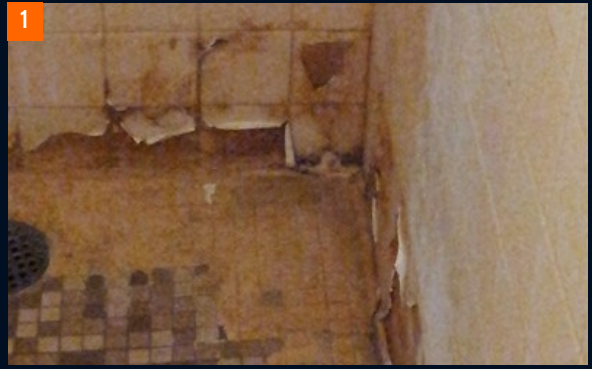
Remove existing coating. Seal Floor from leaking water. Repair damaged tiles, and missing tiles. Provide a non-slip surface. Make cosmetically appealing. Ensure easy cleaning. Provide lasting wear-resistance and protection from further damage. The grout between the tiles has been removed over time due to heavy cleaning with bristle brushes, therefore allowing water to bleed through the walls and onto the public walkways, causing a slip hazard and water damage to the dividing walls. After several attempts of regrouting, the customer tried installing a truck liner product to seal the floor. Shortly thereafter, the coating peeled off and created a cosmetic mess and made it difficult to clean. When trying to remove the failed truck liner, several tiles broke and cracked, causing more water issues.

1. Existing Conditions
2. Grouting with Belzona 4111
3. First coat of Belzona 5811 encapsulated with Belzona 9221
4. Application completed with a second coat of Belzona 5811
