# BELZONA REPAIR TO LOADER TYRE SIDEWALL

ID: 4669

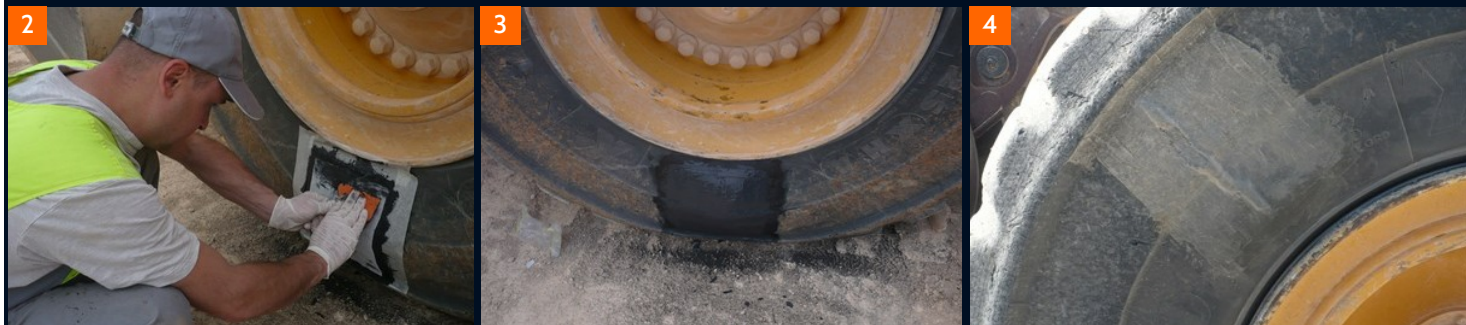
## PHOTOS

There was a large crack in a tyre, but it was not leaking and the steel reinforcement was still in good shape. Customer needed to keep the loader in operation.

1. Damaged tyre on wheel loader
2. Application in progress
3. Application finished
4. Site revisited after 3 months, the tyre is still in perfect shape

Application was carried out in accordance with Belzona Know-How System Leaflet SHM-9.

The two alternatives were either to replace the tyre or to dismantle it and transport it to the nearest workshop. Belzona repair was carried out during the weekend and customer didn't lose any production time. The Belzona repair prevented further deterioration of the tyre and was performing well when expected three months later.
