# BELZONA PROVIDES LONG-TERM PERFORMANCE IN BRIDGE JOINTS

ID: 4672

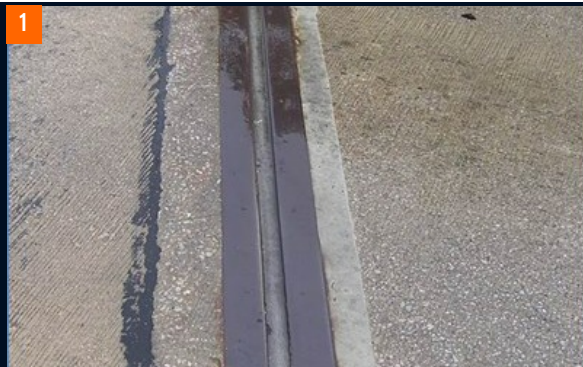
Joints needed to be sealed between existing armor plates on the bridge

1. Application of Belzona 4521 between the armor plates
2. The intentional pinhole in the bay beneath Belzona application remains unchanged after 5-year service
3. The bays on the east end of the bridge beneath Belzona application shows no signs of leakage after 5-year service

Application was carried out in accordance with the Belzona Know-How System Leaflet FPA-6 using approximately 200 cu in of Belzona® 4521.

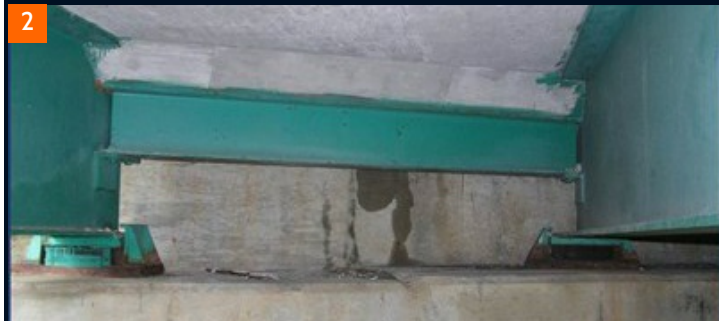
Belzona solution has a long successful history providing long term performance. After 5 years in service, Belzona® 4521 application was reviewed and showed no signs of leakage after several hours of hard rain. An intentional pinhole was added during installation to test failure resistance. Pinhole also remained unchanged after 5 years. A conventional silicone joint material installed on the other part of the bridge began leaking within 12 months of being placed.
