# BELZONA ENSURES LONG-TERM PROTECTION OF TUGBOAT HULL

ID: 4673

Hull plates of a 103' tugboat operated by the refinery

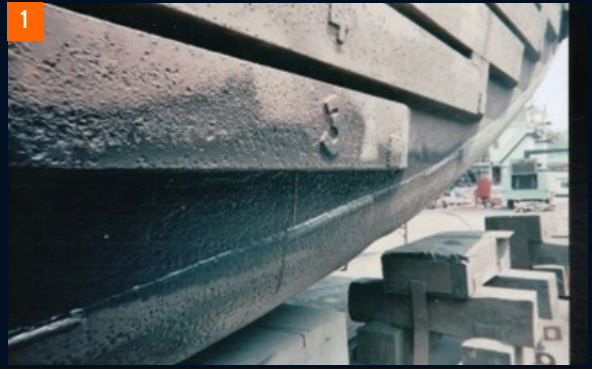
1. Image of hull plates pressure washed and in the process of abrasive blasting
2. Hull plates coated with Belzona 5811
3. After 4 years in service, the coating is glossy and tightly adherent
4. After 7 years in service, the coating is virtually unchanged

The application was carried out in accordance with Belzona Know-How System Leaflet SOS-2. Belzona 5811 was applied via a single-component airless spray.
