# BELZONA INSITU SHAFT REPAIR SOLUTION SAVES DAYS OF LOST PRODUCTION

Main drive roller on conveyor loading finished product to trains.

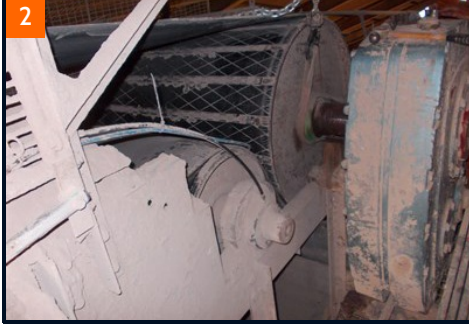
Bearing Failure had caused severe damage to the shaft stopping the loading of trains and the ability to meet customer deadlines potentially costing the quarry hundreds of thousands of pounds in lost revenue. Traditional repair method of complete drum replacement would require the removal of the building's roof and some of the structural frame which houses the conveyor, hire of a crane & manufacture of a new roller and rubber lagging which could take over five days to complete, this was no acceptable to the quarry or their customers.

Severe damage to conveyor roller drive shaft View of the tight application area Former fabricated on site to create new bearing mounting surface Shaft repair being carried out insitu without the need to remove anything from the conveyor

The repair was carried out in accordance with Belzona System Leaflet MPT-2 For rebuilding damaged shafts using forming techniques
