# CORROSION PROTECTION OF DISTRICT HEATING PIPEWORK WITH BELZONA

ID: 4677

District heating system. Pipework in access chamber.

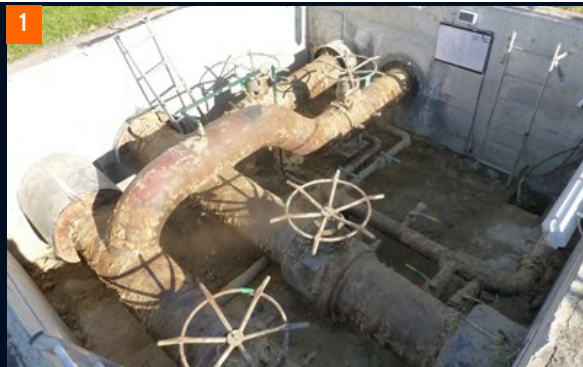
Corrosion under insulation and on the pipes, valves and other naked steel parts, due to water penetrating into the chamber.

1. General view of corroded pipework in the access chamber 2 Blasting, with dry ice 3. Coating the hot feedpipe with Belzona 5851 4. Completed work, with Belzona on all exposed steel parts
