# BELZONA SEALS CORRODED SEWAGE PIPE AT BUSY POLICE HEADQUARTERS

ID: 4678

Police Headquarters, Bedfordshire UK

March 2013

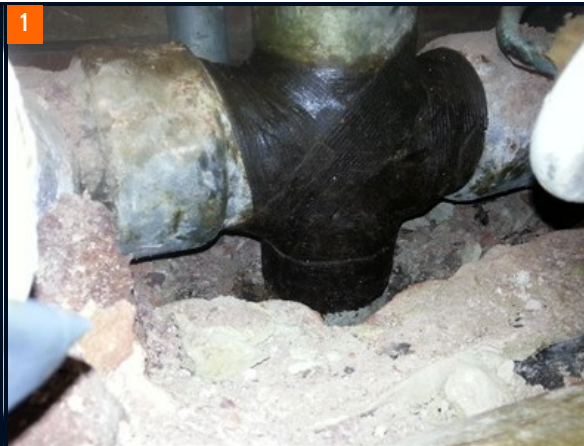
The customer had tried to cure the leak by wrapping a type of adhesive tape around the corroded area. When this failed they contacted Belzona for a fast, cost effective, permanent and quiet solution.

1. Corroded pipe wrapped with adhesive tape
2. Adhesive tape removed showing corroded hole and crack
3. Corroded area after cleaning and then abrading with MBX Bristle Blaster
4. Completed repair

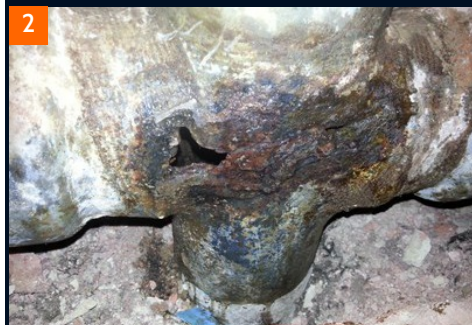
A 4" cast iron sewage pipe behind toilets on the 3rd floor started leaking at the point where 4 x pipes connect, causing water damage to the toilet blocks on both floor levels below.
