# BELZONA REPLACES MECHANICAL MOVEMENT JOINTS

ID: 4679

Mechanical movement joints in floor of Hospital

Hospital, Newcastle Upon Tyne, UK

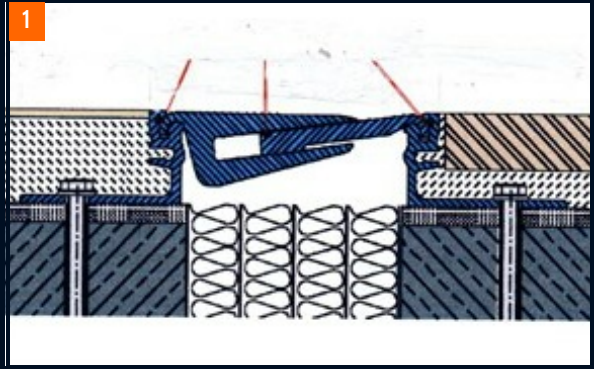
The new building was built approx. 3 years ago and mechanical movement joints were installed throughout the building. Over the 3 year period there has been a lot of movement within the building resulting in the gap on the joints increasing to the extent that they are now failing and allowing cleaning detergents to by-pass the sealing "O" Rings on the joints and to leak into the rooms below, some of which are operating theatres.

1. Diagram of the original mechanical joint
2. Sliding components of expansion joint removed
3. Aluminium spacer bar being fitted in centre of the joint
4. Finished expansion joint
