# TRANSFORMER BUSHING LEAK SEALED WITH BELZONA

ID: 4682

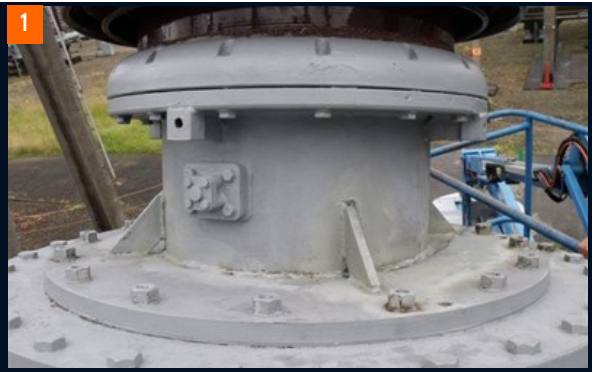
Two 19 inch diameter bushings on a transformer were leaking oil. The leaks were coming from cracks in four steel support struts.

1. Bushing before.
2. Struts before application showing crack.
3. Transformer after overcoating with Belzona 5831
4. Plate bond after overcoating with Belzona 5831

The repair was carried out in accordance with an adapted version of Belzona system Leaflet SOS\_1. The leaks were first stemmed using Belzona 9611. Pre blasted plates were then bonded into place around the struts using Belzona 1161, the purpose of these plates was to give the structure back some strength so the cracks in the steel would not propegate. The repairs were then protected with Belzona 5831.
