# BELZONA EXPANDS THE LIFE OF EXPANSION JOINT

ID: 4684

During the start-up, the 34inch expansion joints in the flare header started leaking forcing the plant to shut down under this emergency situation.

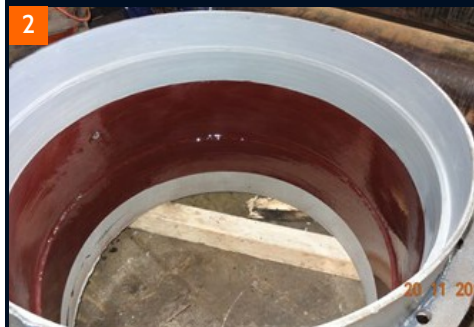
1. Lining in action
2. Lining completed
3. Expansion joint application
4. Application finished

The application was carried out in accordance with modified Belzona Know-How System Leaflet MPT-06. Rebuilding and machining of sealing faces was carried out with Belzona 4301. Internal coating/non sealing faces were coated with Belzona 4311.
