# CLARIFIER TROUGHS RESTORED WITH BELZONA

ID: 4685

Effluent clarifier unit.

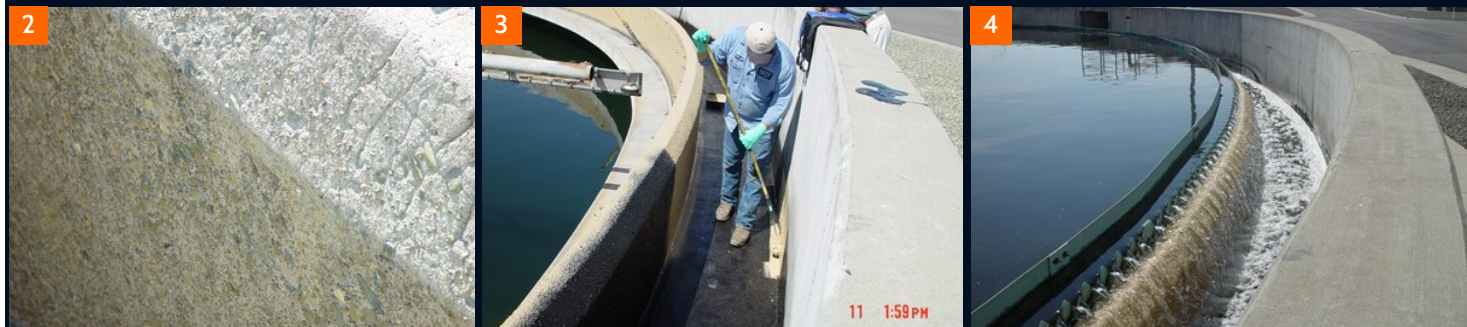
Concrete clarifier troughs had deteriorated to point of exposing the aggregate in the concrete.

1. Clarifier trough before application - overview
2. Clarifier trough before application - detail
3. Belzona 5811 application
4. Clarifier trough in operation after coating

Application was carried out in accordance with Belzona Know-How system Leaflet TCC-15.

Belzona® 5811 coating eliminated need for costly replacement of concrete clarifier troughs. Based on the success of this application, customer not only applied Belzona to a second clarifier but also specified Belzona® 5811 for all immersed metals for their new and much larger additional wastewater facility.
