# BELZONA PROTECTS WASTEWATER PUMP FROM EROSION-CORROSION

ID: 4688

Pumps in a regional Wastewater Authority.

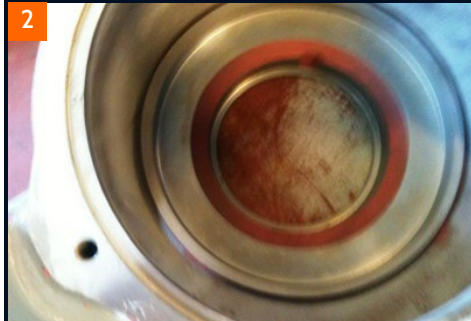
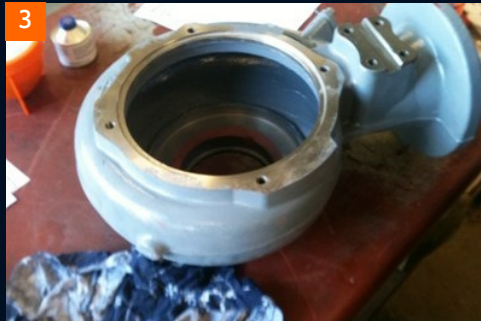
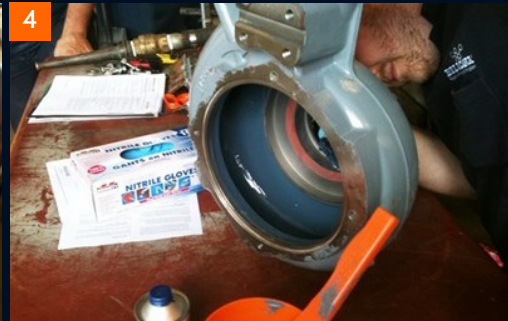
## PHOTOS

High levels of erosion-corrosion caused by entrained solids in wastewater media being pumped for processing.

1. View of new cast steel pump volute
2. Prepared surface by abrasive blasting
3. First coat of Belzona 1321 (Grey) applied
4. Second coat of Belzona 1321 (Blue) applied

Application was carried out by brush in accordance with Belzona Know-How System Leaflet CEP-03.

Regional waste water authority routinely replaces its pumps, as it has been unsuccessful with previous coatings to protect against erosion and corrosion of entrained solids through its waste pumping system. Coating will allow client to continue using more cost effective steel castings instead of looking at more exotic alloys. The easy application of the Belzona 1321 in two colors and two coat system allows the internal maintenance team to complete the repairs internally and observe the level wear before it becomes critical.
