# BELZONA SEALS LEAKING BALCONY ROOF AT WORLD FAMOUS COLLEGE

ID: 4689

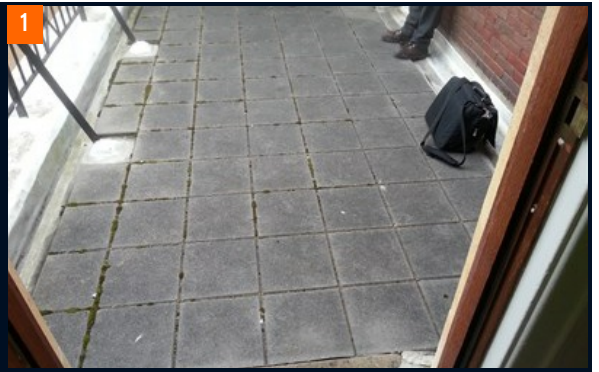
The asphalt roof was leaking underneath the concrete slabs, causing water damage to the rooms below. To repair the roof the College was planning to remove the concrete slabs, replace the asphalt roof and then reinstall the concrete slabs.

1. Leaking balcony roof with paving slabs
2. Close up of paving slab edge
3. Gaps between slabs filled with Belzona 4131
4. Balcony roof coated with Belzona 3131 system with 3rd coat incorporating Belzona 9231 aggregate anti-slip system
