# BALCONIES WATERPROOFED WITH BELZONA

ID: 4691

Balconies on Victorian era hotel

Boutique Hotel, London

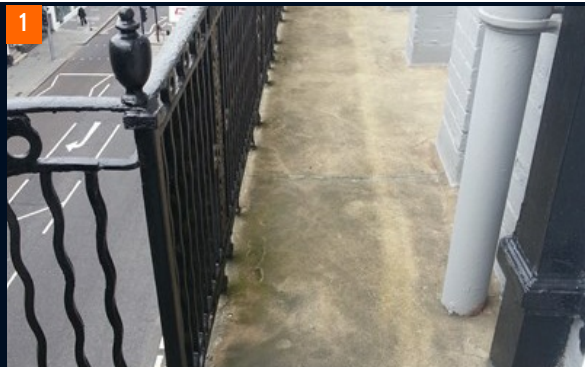
The aging balconies had numerous fine cracks and the hotel had been suffering from water penetration issues. With high occupancy rates a quick turnaround was essential.

1. Unprotected balconies
2. Contractor carrying out application
3. & 4. Completed work

Application was carried out in accordance with a modified version of Belzona Know-How System Leaflet TCC-15. the Belzona 5811 was applied using brushes and squeegees.
