# QUICK AND EASY DOOR REPAIR WITH BELZONA

ID: 4692

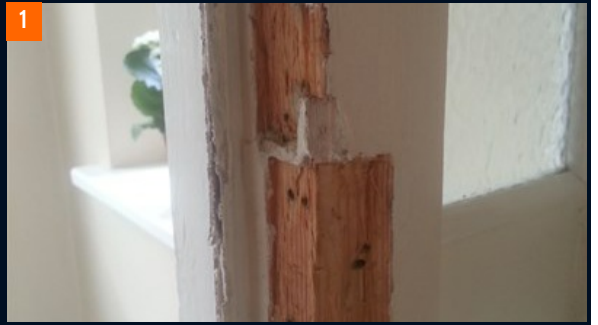
A new door had been fitted with a new lock and catch. The position of these had to be changed leaving two cut outs in the door frame from the old lock and separate catch.

1. Damaged door frame
2. Applying Belzona 8111
3. Completed wood repair
4. Painted finish
