# BELZONA RESTORES BED ON A PRESS BRAKE

ID: 4693

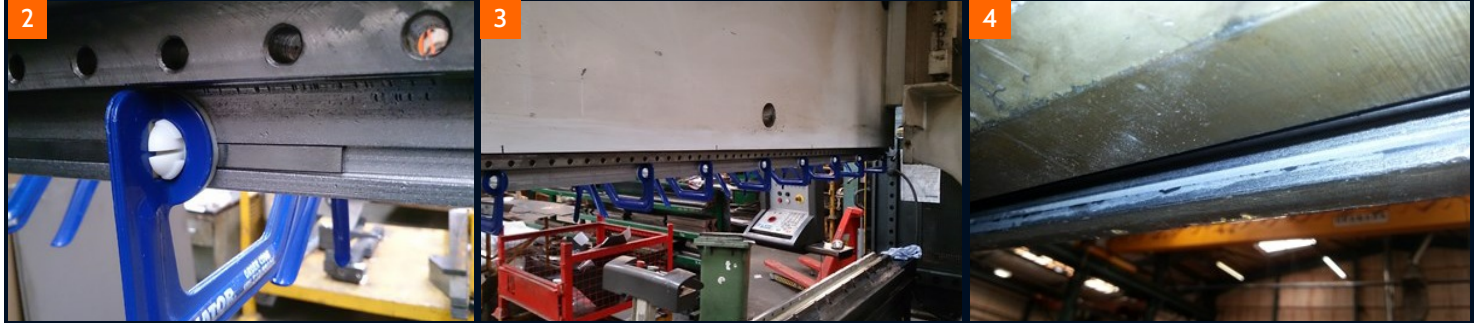
The locating bed on the press had worn over time due to sliding different shaping tools into place. This was leading to the shaping tools sitting at an angle and producing inaccurate results.

1. Damaged area after surface preparation
2. Area to be rebuilt
3. Forming plates being held into place
4. Completed application

Application was carried out in accordance with Belzona System Leaflet GSS-8. Forming boards were made and coated with Belzona 9411 (Release Agent). They were then held in place along the length of the press. Belzona 1121 was injected to the require depth. Once cured the formers were removed revealing the new surface.
