# EFFLUENT CLARIFIER TANK REFURBISHED WITH BELZONA

ID: 4694

Concrete effluent tank

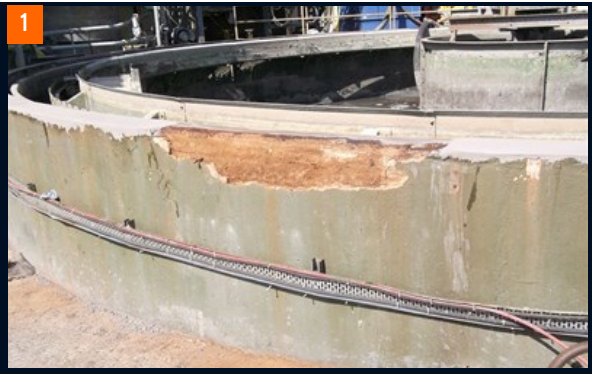
Breakdown of the concrete substrate due to water ingress and freeze thaw cycles had left the tank at risk of stoppages to production which the client could not afford. Traditional repairs or replacement would take too long and did not fit into the client's production schedule. The client only had a five day window which they could have the clarifier off line,

1. Area of damage to concrete substrate
2. Application of Belzona 4131
3. Close up of completed application
4. Completed application, \*note customer painted the tanks outside after coating with Belzona 5151 to match corporate colour scheme.

This Belzona solution was chosen as the Belzona 4131 needed minimal cure time meeting the clients demanding schedule. The Belzona 5811 & Belzona 5151 were applied to extend the life of this crucial site asset by stopping any further water ingress into the substrate.
