# BELZONA 'RUBS' TUGBOAT THE RIGHT WAY

ID: 47

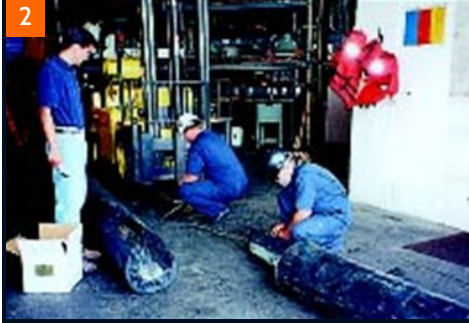
1. Motor vessel projector.
2. Split rub-rail.
3. Applying Belzona 2111 (D&A Hi-Build Elastomer).
4. Finished application is ready for service.

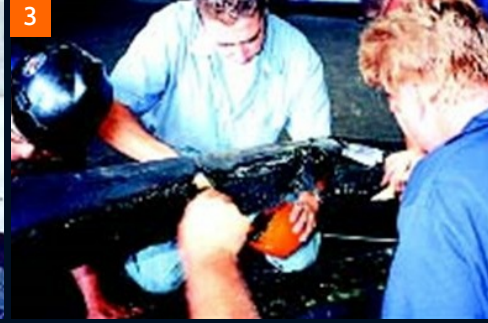
Split rub-rail

When installed, the outer edge of the large rubber extrusion is under tension and the inner edge is under compression. During vessel assist operations, the rub rail (15,000 lbs each) split.

The job was successful. Rub rails still split but not where Belzona was applied. Now they cut out the split and bond in a new section with Belzona® 2111 (D&A Hi-Build Elastomer).
