# BELZONA ALLOWS HOUSTON CLARIFIER TO BE CLEAR AGAIN

ID: 4701

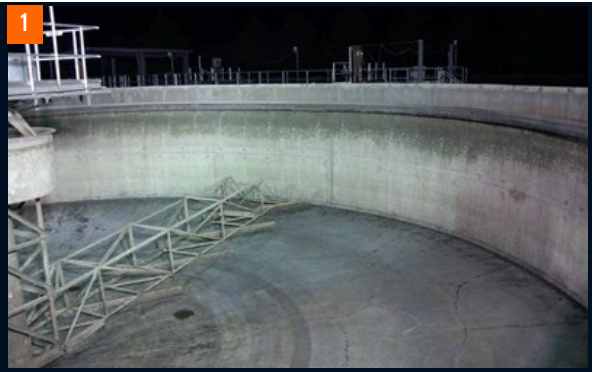
With damaged concrete and no coating, the trough was hard to keep clean, taking 2-3 times longer than when new.

1. Overall view of clarifier
2. After rebuilding with Belzona 4131
3. Completed project
4. Completion application
