# BELZONA KEEPS NATURAL GAS LINE GOING

ID: 4704

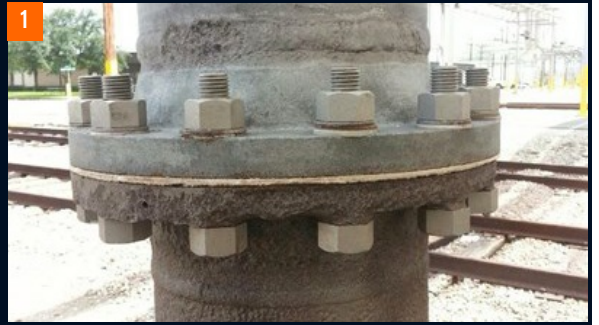
Upon customer inspection they found the pipe near the flange area becoming thin-wall and they also had concerns about corrosion on the flange. This is the natural gas line to the plant and they could not go down for the repair without the plant going down also.

1. After blasting to prep.
2. Belzona 5811 applied to protect.
3. Resin wrap applied.
4. Top coat for protection.

Unit was blasted using sponge media for non-spark preparation. Belzona 5811 was then applied to protect against CUI, then a resin wrap was applied to give strength back to the line. A top coat of Belzona 5111 was applied for further protection.
