# COOLING WATER PIPE REBUILT AND PROTECTED WITH BELZONA

ID: 4706

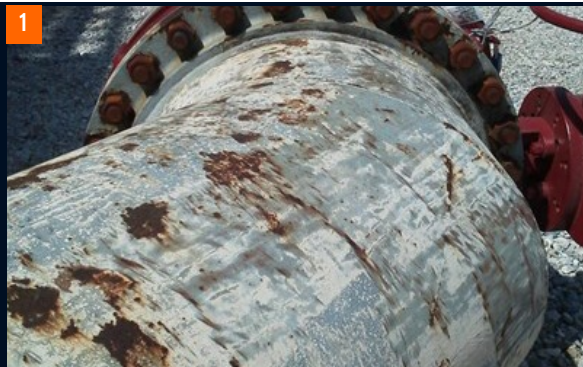
Splash and spill from the nearby cooling tower caused severe pitting on the top portion of the cooling water pipes. Pipes were so thin that leaks were springing up weekly.

1. Before application.
2. Through-holes and pitting filled.
3. Completed application.
