# BELZONA PROTECTS WALLS AND FLOORS AT CIDER PLANT

ID: 4707

Cider producer, Herefordshire, UK

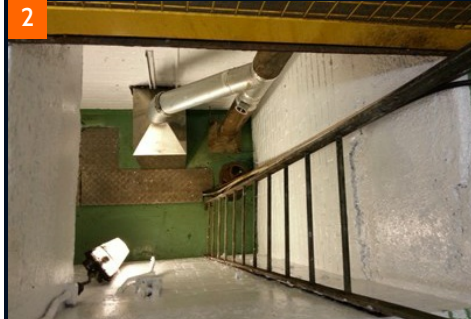
The area was un-hygenic and also needed brightening up with materials that were easy to clean. The floor also needed a safe non-slip surface.

A very damp and dirty pit area.

1. View into pit before application
2. pit after application
3. walls before application
4. walls after application

Application was carried out in accordance with Belzona Know-How System Leaflets WPA-2, FPA-1 and FPA-8. The damaged areas of the floor were rebuilt using the Belzona® 4131 before coating with Belzona® 5231. Belzona® 5111 system was applied to the walls.
