# BELZONA GIVES OLD PROPERTY NEW LEASE OF LIFE

ID: 4708

Old farm house walls.

Farm house, Worcestershire, UK

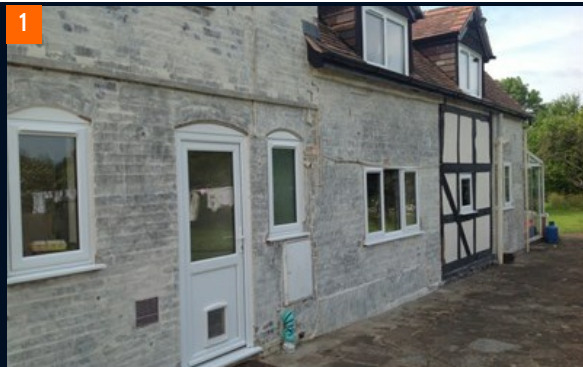
1. Surface Preparation
2. Application of Belzona 3911 (PSC Conditioner)
3. Completed Belzona 5151 Application.

Application was carried out in accordance with Belzona Know-How System Leaflet WPA-1. A mechanical wire brush was used over the entire surface to remove loose material. After treating with fungicidal wash the Belzona® 5151 system was applied.
