# BELZONA SAVES OFFSHORE OIL & GAS PLATFORM FROM SHUTDOWN

ID: 4709

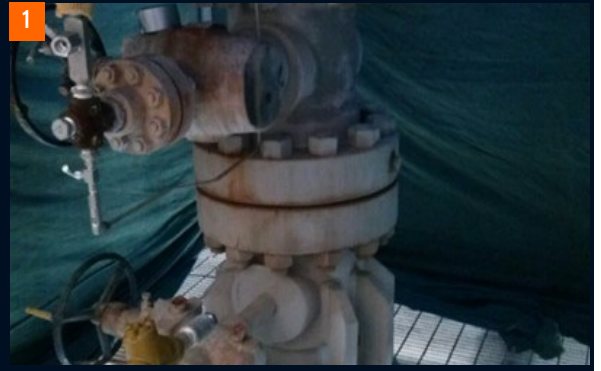
External corrosion to well conductor caused natural gas leak of 85 PSI.

1. Photo of well conductor.
2. Photo identifying leak area.
3. Abrasive blasting in progress.
4. Completed Composite Wrap holding 85 PSI, no leaks.
