# BELZONA HELPS PLATFORM QUALIFYING FOR PLUG & ABANDON PROJECT

ID: 4710

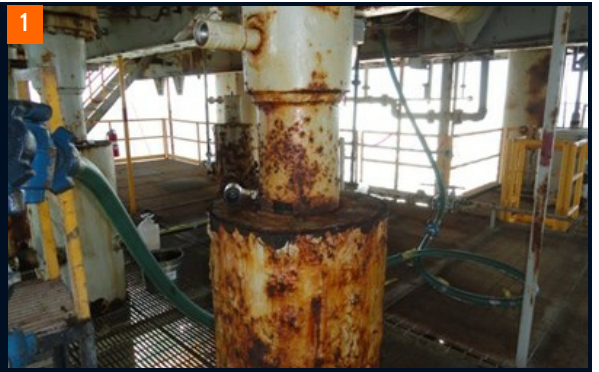
External/Internal corrosion caused many hole through defects. Conventional welding would have been very time consuming and expensive. Additionally, a hot work repair would have caused shut down of the platform resulting in a great loss of production and income.

1. Well conductor showing external corrosion.
2. Building fillet with Belzona 4141.
3. Installing Belzona 1121/Belzona 9371/Belzona 4151.
4. Completed Belzona Composite Wrap.
