# BELZONA REPAIRS PST AT WATER TREATMENT PLANT

ID: 4711

Concrete wall of a Primary Settlement Tank (PST)

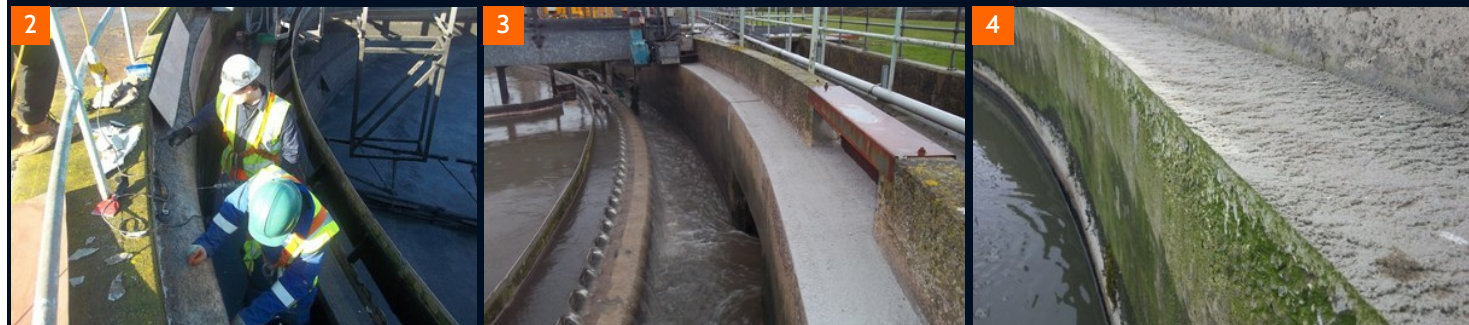
Walls of the running track had become badly worn and damaged over time due to rotation of the distributor. Some areas had been unsuccessfully repaired in the past.

1. Damaged running track and failed previous repairs
2. Shuttering boards being installed
3. Completed repair back in service
4. Repaired areas 12 months on

Application was carried out in accordance with Belzona Know-How System Leaflet FPA-1 & FPA-6. Once the surface was prepared, shuttering boards were fitted to the side walls to enable the Belzona® 4131 to be applied to accurate levels. Once the Belzona 4131 had cured the boards were removed and expansion joints cut into the repaired areas. These joints were then sealed with Belzona® 2211.
