# BELZONA SOLVES THROUGH WALL CORROSION ON SLUDGE BUFFER TANK

ID: 4712

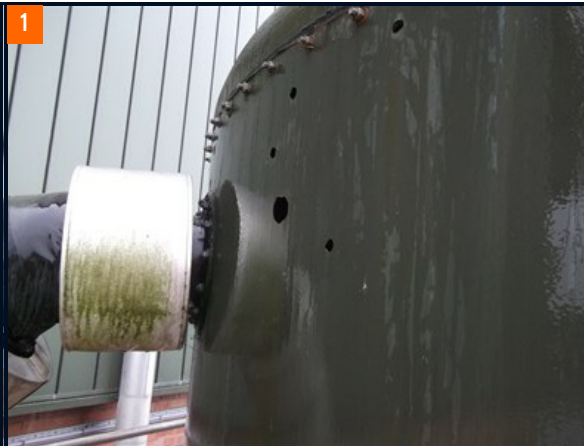
The sludge buffer tank was suffering from through wall corrosion at the vapour interface level. The tank could not be taken off line for an extended time which traditional repair methods would require due to demand. Any repairs would have to be carried out without hot works or the use mechanical equipment due to the risk of sparks.

1, Close up view of through wall defects  
2, Plate bonding with Belzona 1161 3,  
Repairs coated with Belzona 5831 4,  
Inspection in 2015

The application was carried out in accordance with Belzona Know-How System Leaflet TCC-3. After cleaning the areas, surface preparation by hand abrasion was carried out. Repair plates pre-coated with Belzona 5831 were cold plate bonded over the through wall defects using Belzona 1161. Finally Belzona 5831 was applied to the entire repair areas.

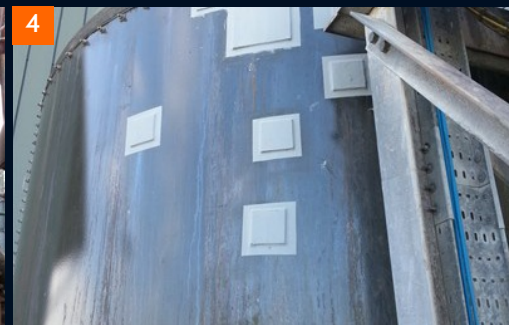
The client had only been able to run the Buffer tank at a reduced capacity of 65%. No other alternatives were deemed to provide a viable solution to the customers requirements. Belzona solution kept the site running with minimal disruption and was carried out without hot works or the use mechanical equipment so presenting no risk of sparks. The job was inspected in 2015 and found to be in perfect condition.
