# BELZONA EXTENDS LIFE OF CYCLONE CONES IN QUARRY WASH PLANT

ID: 4713

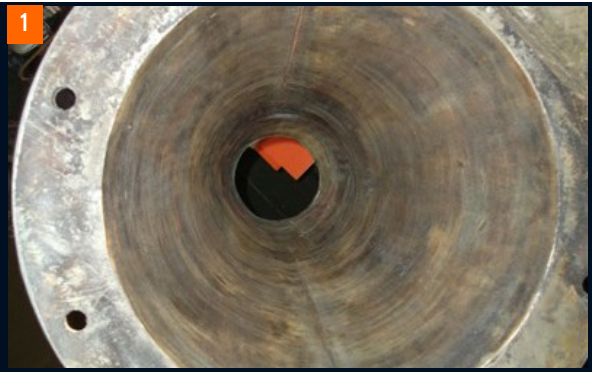
The cones suffer heavy levels of abrasion. The mean times between failures of the cones was not acceptable even after the rubber coating was applied and continuing stoppages of the plant had large cost implications. Belzona was selected for a trial application to increase the working life of these components.

Cones on cyclone wash plant filtration. Non-protected cones were failing within one month and rubber coated cones only lasted for six months.

1. Cone prior to application
2. Clients staff carrying out application
3. Belzona 1812 during application
4. Completed application of Belzona 1812 to cone
