# BELZONA SEALS LARGE BUND AREA

ID: 4714

Chemical Bund on large manufacturing site

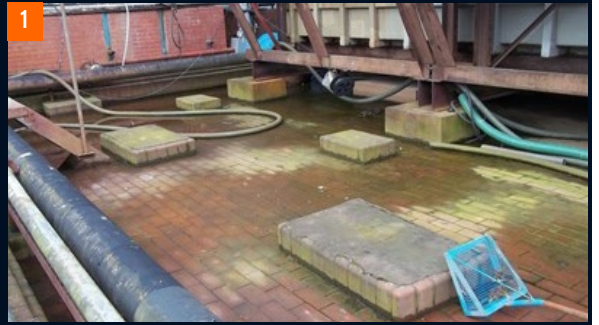
The site is very keen on keeping up there high standards in health and safety and environmental issues and so regularly test for leaks .The bund was leaking in many areas through the brickwork.

1. Before application
2. Creation of fillets at wall/floor joint with Belzona 4131
3. Application of first coat Belzona 5811
4. Completed application
