# BELZONA SOLVES FINLOCK GUTTER ISSUES

ID: 4715

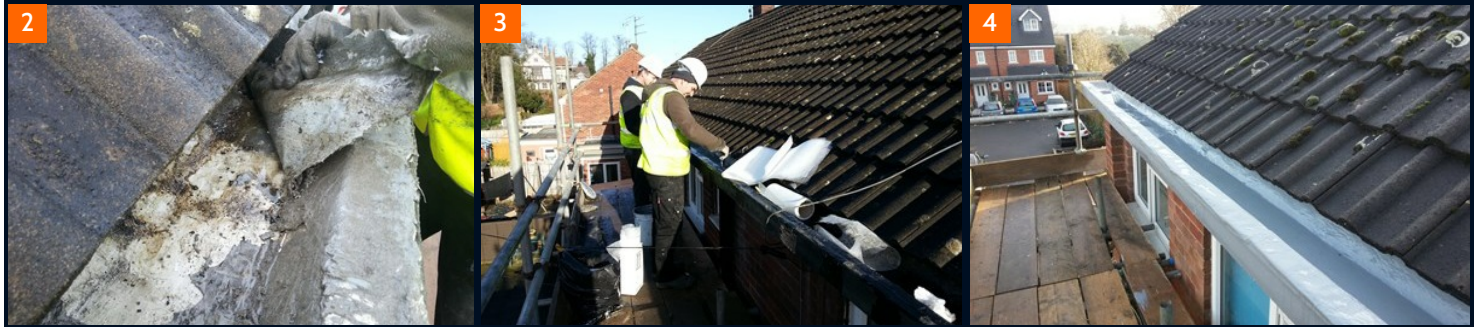
Finlock gutters had begun to leak into the properties.

1. Before Application 2. Removal of existing liners 3. Application in progress 4. Completed Application.

Application was carried out in accordance with Belzona Know-How System Leaflets RPA-6 and RPA-11. Any damaged areas of concrete were repaired using Belzona 4141 followed by complete coating with the reinforced Belzona 3131 system.
