# BELZONA HELPS KEEP THE PORT OPEN.

ID: 4716

Hull of a survey vessel operating on the river Thames.

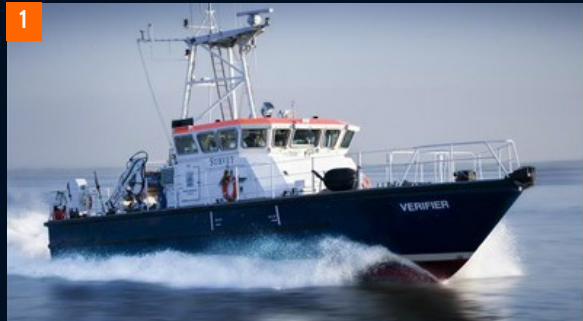
After 10 years of service on the river the hull of the vessel was suffering from cavitation around the propellor area. Previous repair method had been welding.

1, The vessel 2, The affected areas 3, Cleaned, blasted and Belzona 1111 applied 4, Belzona 1341 applied

The application was carried out in accordance with Belzona Know-How System Leaflet SOS-1 & SOS-2, Belzona 1111 was used to build up the worst affected areas and then Belzona 1341 was then brush applied to provide overall protection.
