# BELZONA FENDER REPAIR

ID: 4718

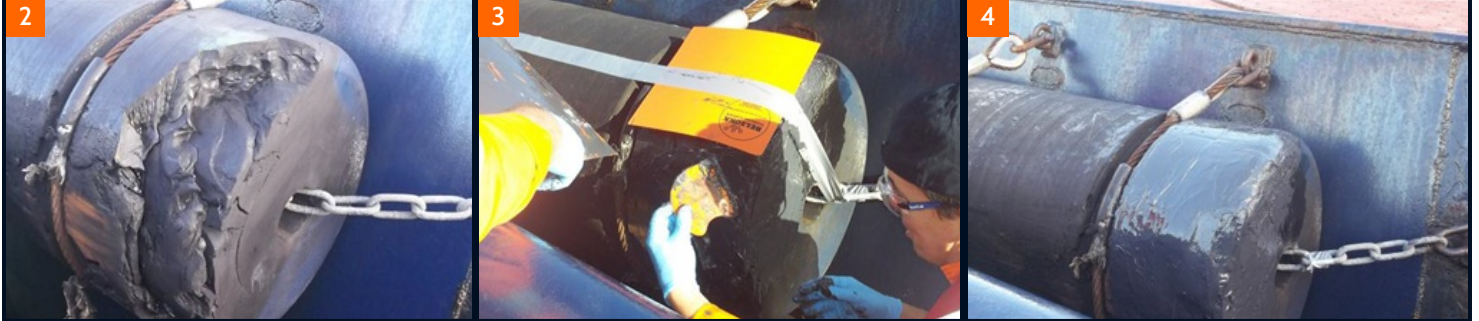
## PHOTOS

Fenders on these boats were getting damaged which in turn increased likelihood of damage during contact with other ships. Replacement during annual docking was costly and replacement at other times interrupted busy schedules.

1. Tug pulled up ready for a fender repair
2. Damaged fender before repair
3. Fender being prepared for the rebuild
4. Completed repair

The Belzona repair solution worked out to be a quarter of the replacement cost, Also the repair didn't cost the company any down time as it was carried out between shifts. The repairs were carried out by the crew of the Tug at the quay side. Within hours the Tug was back in service and operating in a safe manner.
