# BELZONA EXTENDS VALVE BODY LIFE

ID: 4719

Valve from the water cooling system in the power station.

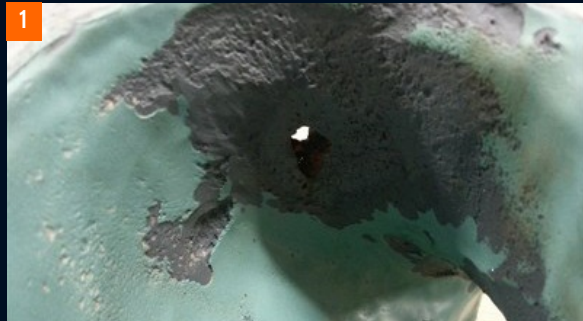
The valve body was suffering from cavitation and would only last 4-6 weeks before breaking through the casting.

1. Through wall erosion damage
2. Blasted and Belzona 1111 applied
3. Belzona 2141 being applied
4. Finished application
