# BELZONA GETS HOT AND HUMID

ID: 4722

## PROBLEM

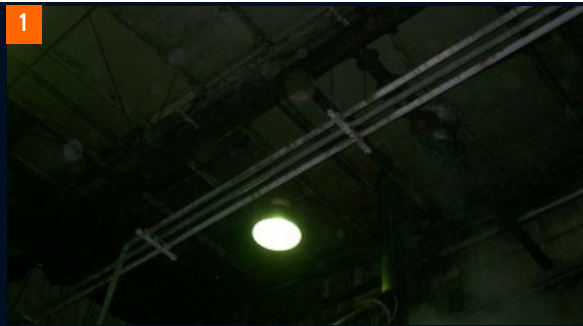
1. Location of gas pipes in ceiling 2. Corroded pipe with constant surface condensate 3. Finished section of pipe from Phase 1.

Application was carried out in accordance with a modified version of Belzona System Leaflet VPF-2. the pipes were hand wire brushed to ST2 standard and then 2 coats of Belzona 5831 applied by brush

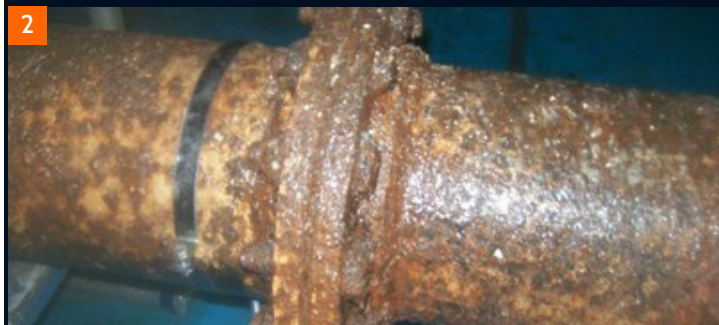
A well known crisp manufacturer had a series of aging gas pipes of diameters ranging between 4 to 8 inch. These heavily corroded pipes were located in the ceilings above production equipment and the packing conveyors. In addition, because of the processes in the rooms beneath, the roof area had excessive heat and humidity, with water condensate perpetually laying on the pipes. Grit blasting was not an option due to production beneath and so Belzona was approached to offer an anti-corrosion system that could be applied in such difficult circumstances.
