# NOVEL USE OF BELZONA TO SEAL TURBINE HALL ROOF

ID: 4725

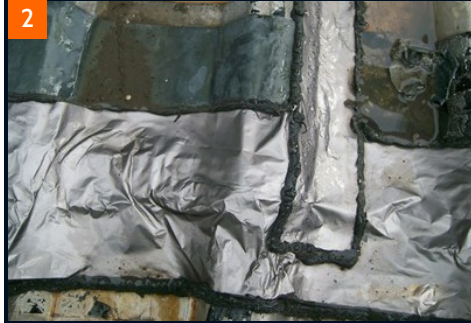
1. General view of turbine hall roof showing Bitumen Flash Band on joints before stripping
2. Close-up of Bitumen Flash Band on joints
3. General view of roof after stripping the joints and sealing with Belzona 3131
4. Another view of the finished roof joints

To allow turbine removal a knife is run down the joints. The joints are easily resealed with a further coat of Belzona 3131 and Reinforcing sheet. Belzona 3131 is easy to apply and lightweight, so procedure can be carried out time and again without detriment to the roof.
