# BELZONA UPGRADES DAMAGED WALLS IN PROCESS AREA

ID: 4726

Damaged walls in process area.

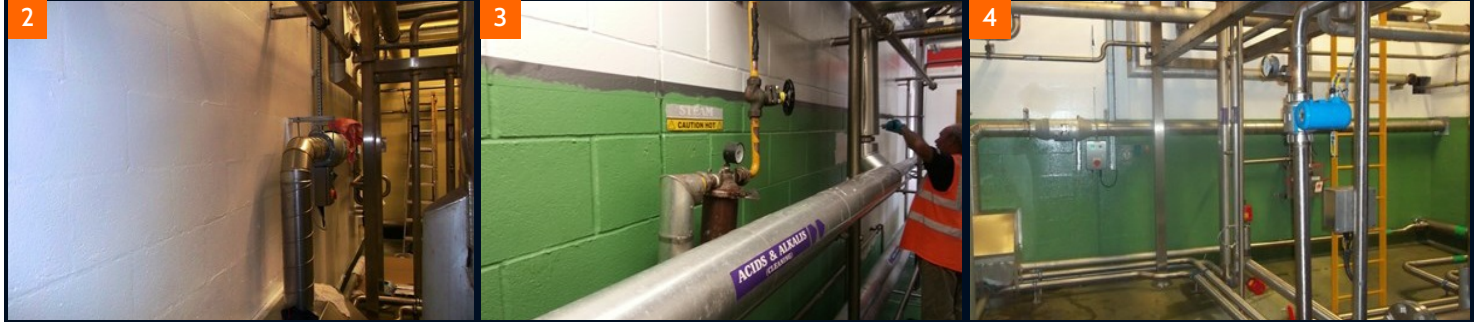
Due to chemical spills and damp conditions the walls were in need of repair and protection.

1. Damaged wall area 2. Belzona 5111 application 3. Belzona 5231 applied 4. Completed application

Application was carried out in accordance with Belzona System Leaflet WPA-2 and WPA-4. The damaged areas of the wall were rebuilt using the Belzona 4131. Belzona 5111 system was then applied to the upper areas and Belzona 5231 to the lower areas to give the aesthetic finish required.
