# BELZONA USED IN WINDMILL REFURBISHMENT

ID: 4728

Old windmill used as accomodation undergoing refurbishment

Windmill, Buckinghamshire, UK

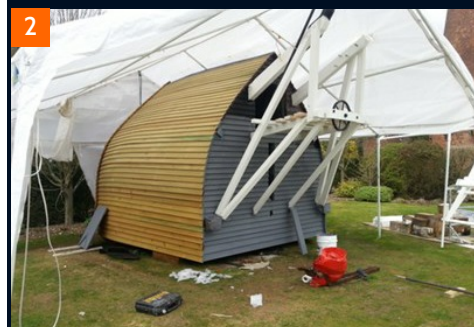
1. The cap on the ground with freshly replaced timbers
2. First layer of Belzona 3111 being applied
3. & 4. Finished application with cap fitted back in place

Once the sails had been removed the wooden cap was taken down and work could commence to replace any rotten or damaged timber. Upon completion of the structural work the fully reinforced Belzona 3111 system was applied in accordance with Belzona System Leaflet RPA-1. With all the overlapping timbers it required the patience of a craftsman to carefully lay the reinforcing sheet into the Belzona 3111 to achieve a wrinkle free finish with the sheet closely following the substrate profile.
