# BELZONA MAKES RAMP SAFE

ID: 4729

A long steel chequerplate access walkway located alongside the community college allowing access to two buildings.

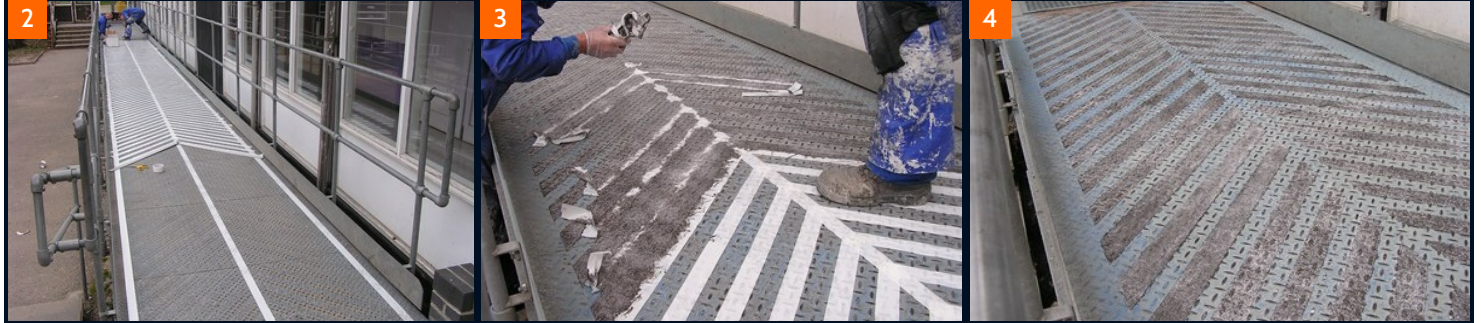
## PHOTOS

The chequerplate had become polished and slippery especially when wet.

1. Long chequerplate walkway before application
2. Chequerplate showing preparation and correct masking to provide chevron pattern
3. Application by brush with immediate removal of masking tape
4. Finished job

Application was carried out in accordance with Belzona Know-How System Leaflet FPA-8. After preparing the substrate and masking the chevron pattern on the surface the Belzona® 1821 was applied and aggregate tamped into the surface before removing the masking and allowing system to cure overnight.

Even though chequerplate is known to have a pattern across its surface this had become polished and had become very slippery especially when wet. The Belzona® 1821 grip system applied along the surface of the chequerplate provided added positive grip and safety for pedestrians.
