# BELZONA REBUILDS WORN STONE STAIRCASES BUILT IN 16TH CENTURY

ID: 4730

Badly worn stone steps on staircases built in the 16th Century

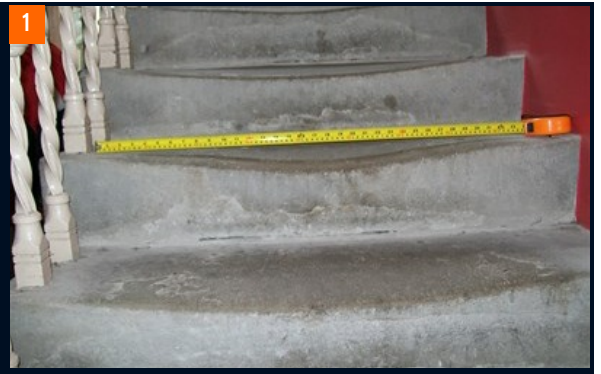
The stone steps on several staircases in this Grade 2 listed College had become badly worn over the last 500+ years of use and so were considered a Health and Safety risk. The steps had worn by up to 75mm deep in the centre, sloping towards the front so were slippery when wet. Due to the design of the stone steps it was not possible to cut out the worn area and repair in the traditional manner of inserting a new block of stone because this would weaken the staircase.

1. Worn stone steps before, with wear up to 75mm deep in centre of step
2. Wooden formers in place and Belzona 4911 being applied
3. Belzona 4131 being installed with wooden former helping keep the repair flat and level
4. Example of step rebuild completed with Belzona 4131
