# STORM TANK AT SEWAGE WORKS REPAIRED WITH BELZONA PLATE BONDING

ID: 4732

Leaking glass lined Storm Tank in Sewage works.

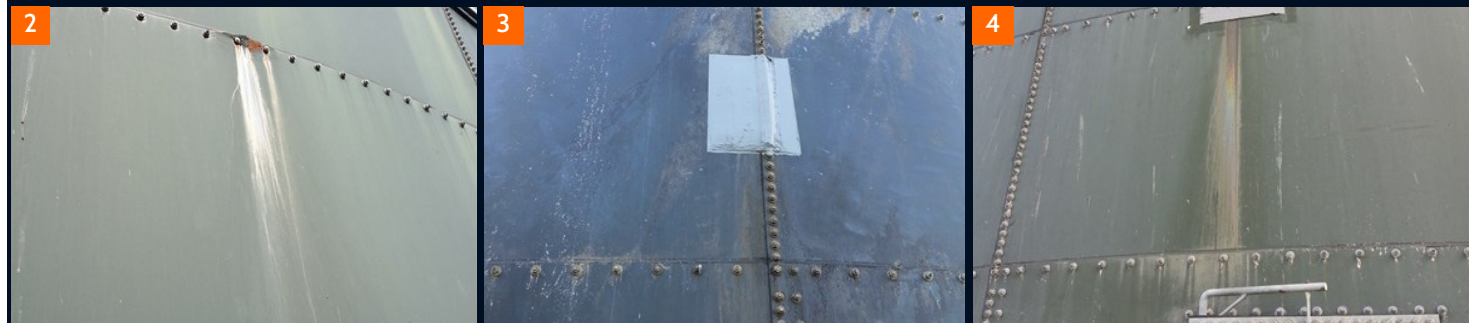
The tank was suffering from corrosion issues around the seam areas. In two places the corrosion was through wall and raw sewage was leaking out of the sides. Whilst a decision was being made as to whether or not to build a new tank or repair the existing was made we were asked to apply some temporary patches so the tank could still be used.

1. Through wall corrosion area requiring cold plate bonding 2. Corroding seam 3. Completed plate bond 4. Patch repair to seam complete

Application was carried out in accordance with Belzona System Leaflet TCC-1 & TCC-3. After cleaning and preparing surface with an MBX Bristle Blaster, Belzona 1211 impregnated into Belzona 9341 (Reinforcement Tape) was used to cover area before conducting a cold plate bond using Belzona 1161.
