# AERATION CHANNEL LEAKS REPAIRED WITH BELZONA

ID: 4733

Leaking joints in sewage aeration channel

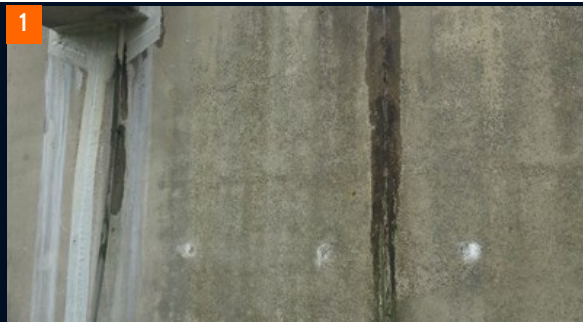
The construction and movement joints were leaking raw sewage to ground. Previous repairs were failing and only channeling the sewage in to the drains. The environment agency were threatening the customer with prosecution if the problem wasn't resolved. The lane is critical to the treatment process and could not be out of action for any length of time.

1. External view of leaking joints and previous attempts to stop leaks
2. Repaired Movement joint 2013
3. Movement joint still going strong after revisiting in 2019 compared to alternative solution.
4. Movement joint still going strong after revisiting in 2019

All joints were repaired in accordance with Belzona Know-How System leaflet WPA-3.

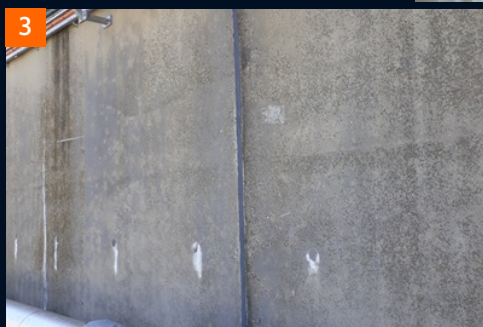
The Belzona repairs were carried out over two days and the tank was reinstated 2 days later. The aeration lane was only out of action for 5 days. After a month of being in operation there are still no leaks. Site was revisited in 2019 showing no damage or wear on the repairs only leaks were shown on alternative solution.
