# BELZONA PROTECTION TO FLANGE EDGES ON GLASS LINED PROCESS VESSELS

ID: 4735

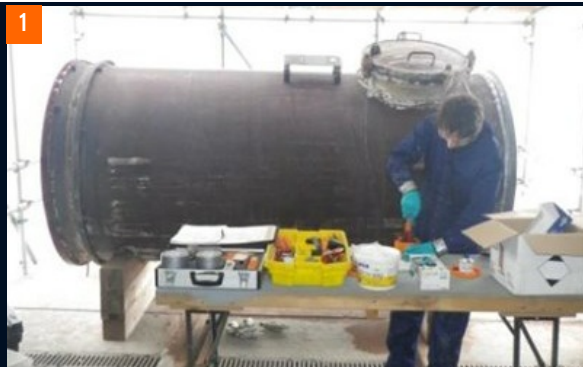
1. Preparation of habitat, product and equipment prior to coating procedure
2. Substrate condition following grit blast preparation
3. Completion of first coat colour coded grey
4. Completion of second coat colour coded red

Application was carried out in accordance with Belzona System Leaflet TCC-3. Specific attention had to be given to the grit blasting and application to ensure damage was not caused to glass lining. The coating must align perfectly to the full circumference of the glass lining in the vessel.
