# BELZONA PROTECTS PIPEWORK ON SEWAGE OVERFLOW SYSTEM

ID: 4740

New high capacity sewage overflow system constructed for the local water company.

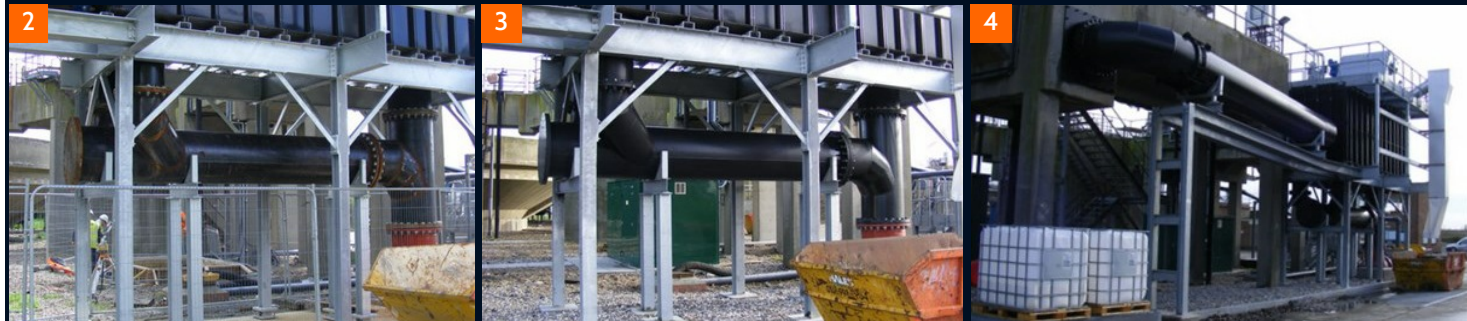
The newly fitted pipework had a paint system which was already showing signs of failure. Client required system to provide long term corrosion protection and be resistant to raw sewage.

1. Upper pipework 2. Lower pipework 3. & 4. Completed pipework

Application was carried out in accordance with Belzona Know-How System Leaflet VPF-2 and the Belzona 5811 Instructions-for Use leaflet.

Belzona 5811 (Immersion Grade)
