# BELZONA REFURBISHMENT OF FLAT ROOF

ID: 4742

Large areas of flat roof over the sports and dining areas.

School, Grantham, UK

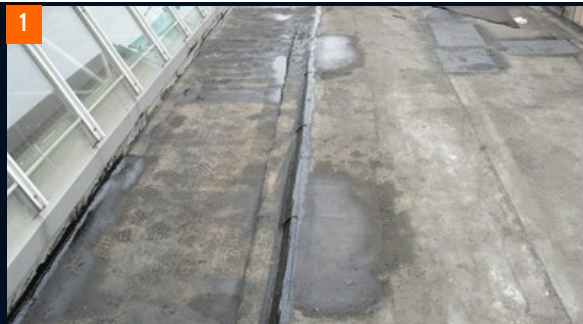
The felt roof had deteriorated allowing numerous leaks into the areas below.

1. Section of roof before work started
2. Completed application
3. Upper section of roof before coating
4. Completed application

Application was carried out in accordance with Belzona System Leaflets RPA-1, RPA-6 and RPA-8. After cleaning the roof and carrying out some localised repairs, a fully reinforced Belzona 3111 system was applied to the entire roof areas.
