# BELZONA IMPOUNDMENT PUMP COATING SIX YEARS ON

ID: 4748

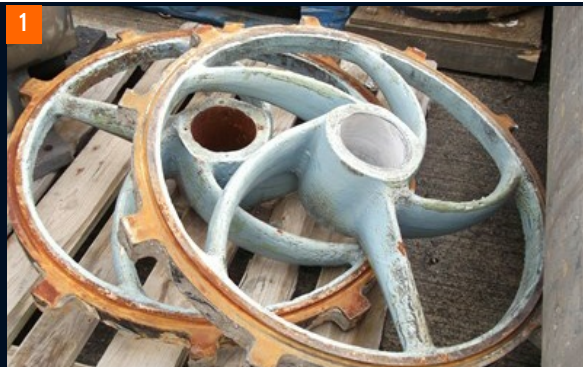
1. Spider bearings after 6 years in service  
2. Pump casing very little wear to the Belzona 1341  
3. Spider bearings re-coated with Belzona 1341  
4. Pump internals after coating
