# BELZONA REPAIRS OIL COOLERS

ID: 4749

Four Heat exchangers for cooling mill oil.

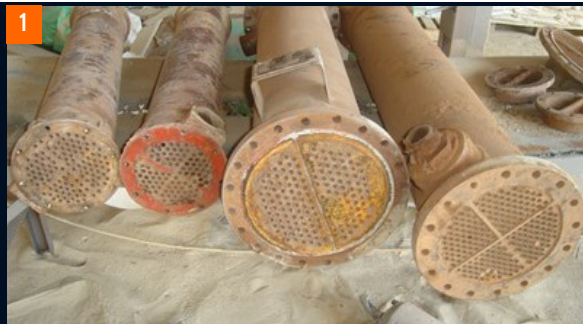
1. Heat exchanger ready for grit blasting
2. The condition of end cover after blasting
3. End cover repaired with Belzona 1311 and protected with Belzona 1391
4. Tube sheet repaired and protected

Application was carried out in accordance with Belzona Know-How System leaflets HEX-1 and HEX-3.

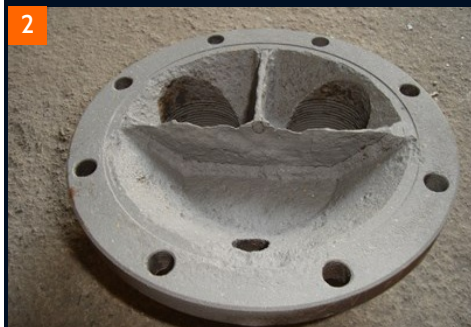
Heat exchangers were suffering from electrochemical corrosion. Gaps occurred between tube sheet and tubes and cooling water and oil started to mix.
