# BELZONA REPAIRS DAMAGED PORCELAIN SHED

ID: 4750

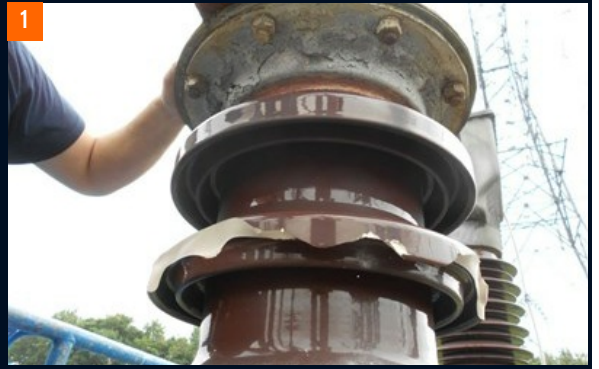
Porcelain shed damaged by contact with mechanical platform access lift during outage procedure.

1. Damaged porcelain shed
2. Elastomer former mould
3. Elastomer former with Belzona 8112 attached to shed
4. Completed repair with innovative rainfall protection
