# BELZONA SEALS EXPANSION JOINTS IN A SHIP LOCK

ID: 4751

## PROBLEM

Water passing through the expansion joints and existing gaps in the retaining walls during the flooding seasons.

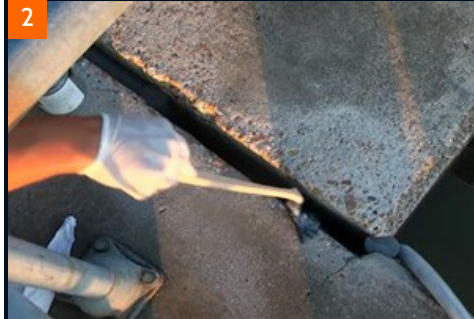
1. Backer rod inserted into the joint following the recommended configuration: Depth=1/2 Width
2. Belzona 4911 Conditioner applied by brush prior to Belzona 4522 application
3. Belzona 4522 injected into the joint avoiding air entrapment
4. Application completed - expansion joints sealed with Belzona 4522/4523 System

The application was carried out in accordance with a modified version of Belzona Know-How System Leaflet FPA-6. A backer rod was inserted into the joint to achieve the correct joint configuration. The area of application was treated with Belzona® 4911 Conditioner. An injection gun was utilized to inject Belzona® 4522 into the joint avoiding air entrapment.
